**HIGHLANDS FARM DAM**

**NDI NO. PA-01099**

**PHASE I INSPECTION REPORT**

**NATIONAL DAM INSPECTION PROGRAM.**

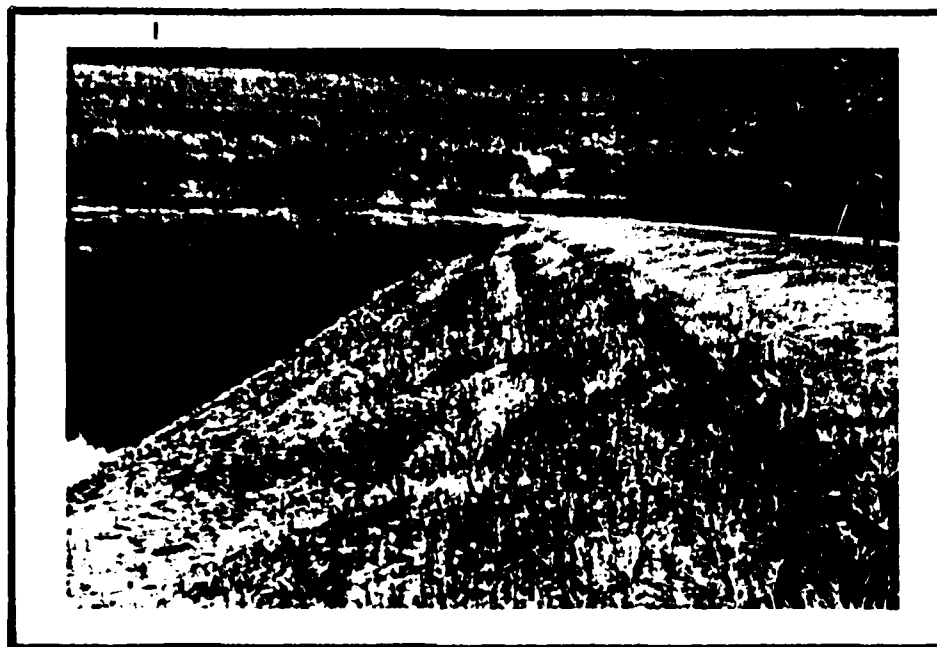
The dam is located in a rather flat area with a nearly level area beyond its left abutment (Photograph No. 2) and a gentle slope at its right abutment. The reservoir was 7.5 feet below its normal pool elevation at the time of inspection.

UPSTREAM SLOPE FROM RIGHT ABUTMENT - NO. 2

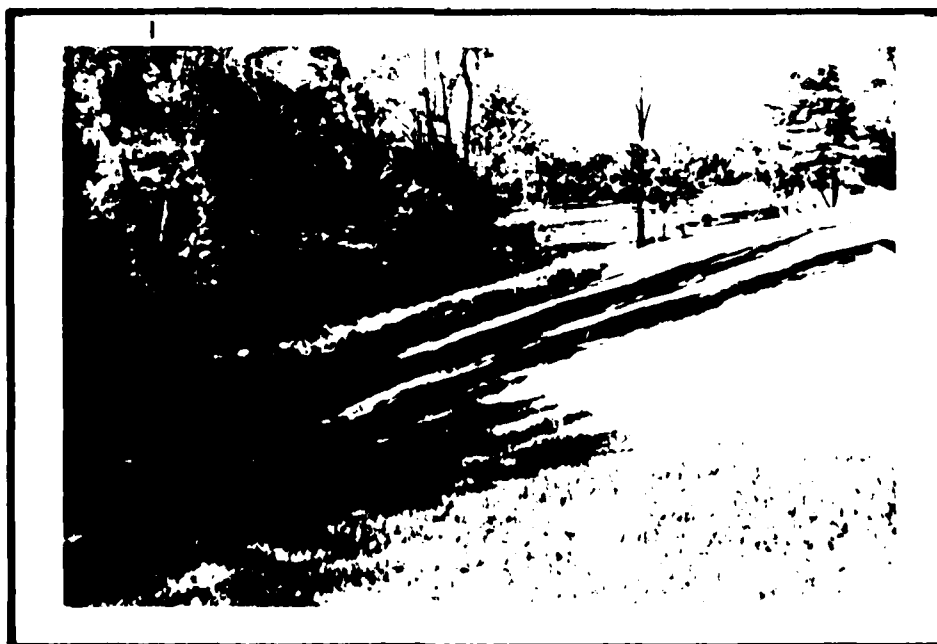
The downstream slope is 3H to 1V (Photograph No. 3). The left side is protected with a well maintained grass mat. The lower part of the downstream slope to the right of the outlet pipe is covered with high weeds. A wet condition of the soil was detected on the lower portion of the slope and at the toe. The high weeds, however, prevented close observation. There were no indications of accumulated seepage water.

The visual inspection of Highlands Farm Dam detected a wet condition near and on the lower part of the embankment near the downstream toe, indicating that some seepage is occurring through the embankment. High and thick weed cover in this area prevented close observation of this condition. The embankment slopes are considered to be adequate for the height of dam under consideration, and appear to be stable.

DOWNSTREAM SLOPE - NO. 3  
NOTE: GROWTH ON SLOPE IN RIGHT SECTION

The overall visual evaluation of the facilities indicates that the Highlands Farm Dam is in good condition. It is recommended that the downstream slope and the toe of the embankment on the right side be cleared of all brush and weeds to permit closer observation of the wet condition.

The operational procedures for Highlands Farm Dam are minimal. It is recommended that the maintenance of the dam include the mowing of the downstream slope on the right side.

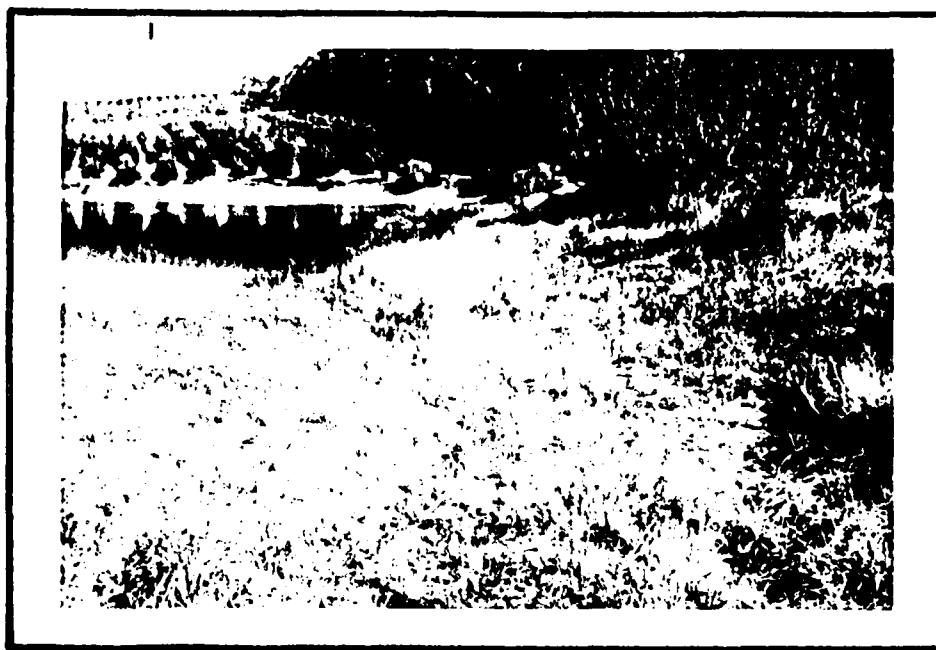
The spillway, located in the left abutment, consists of a shallow, irregular, grassed swale. The control section is about 1.4 feet below the low point in the dam profile. The approach to the spillway is directly from the reservoir. The discharge channel is located to the

left of the embankment through a wooded and poorly defined swale. The uncontrolled spillway is the only outlet. Overflow is reported to occur regularly, especially in spring time.

SPILLWAY LOOKING UPSTREAM - NO. 6

The downstream channel of the spillway should also be cleared of trees and brush over a length of about 100 feet.

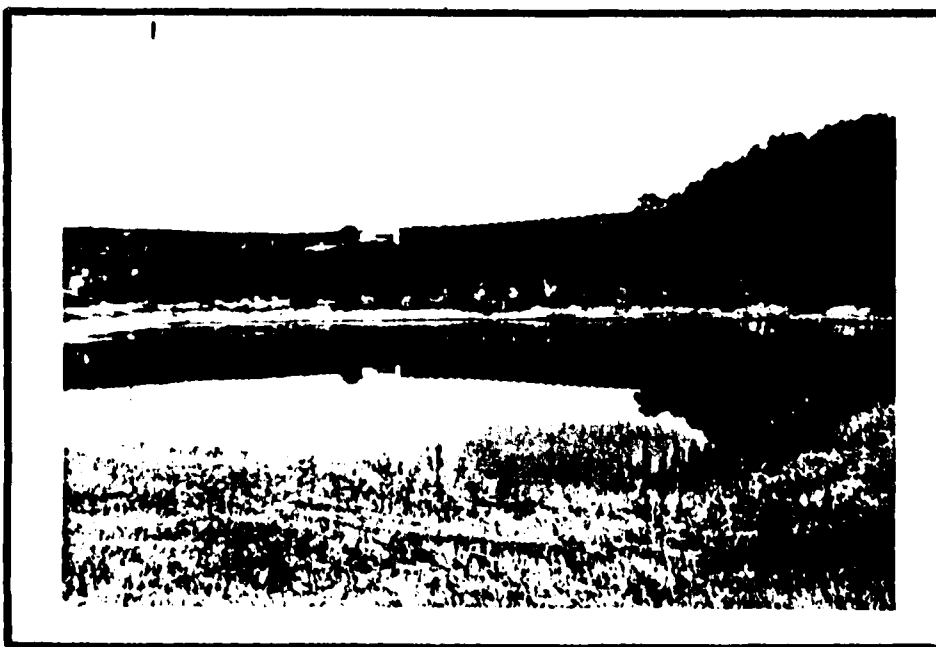
The reservoir has gentle slopes (Photograph No. 7) and is surrounded by cultivated land, mostly orchards. Because of the gentle slopes around the reservoir, sedimentation is not expected to be a serious problem.

RESERVOIR AND DRAINAGE AREA - NO. 7
